RAILROAD COMMISSION OF TEXAS SURFACE MINING AND RECLAMATION DIVISION

URANIUM EXPLORATION INSPECTION REPORT

Mine Name: Weesatch Project Permit Number: 123
 Permittee: Uranium Energy Corporation (UEC) County: Goliad
 Industry Representative(s) Present: Mike O'Leary
 Inspector: Murphy Hawkins, Michael Gay, Jon Brandt, Dean Poth Date of Inspection: March 7-9, 2007

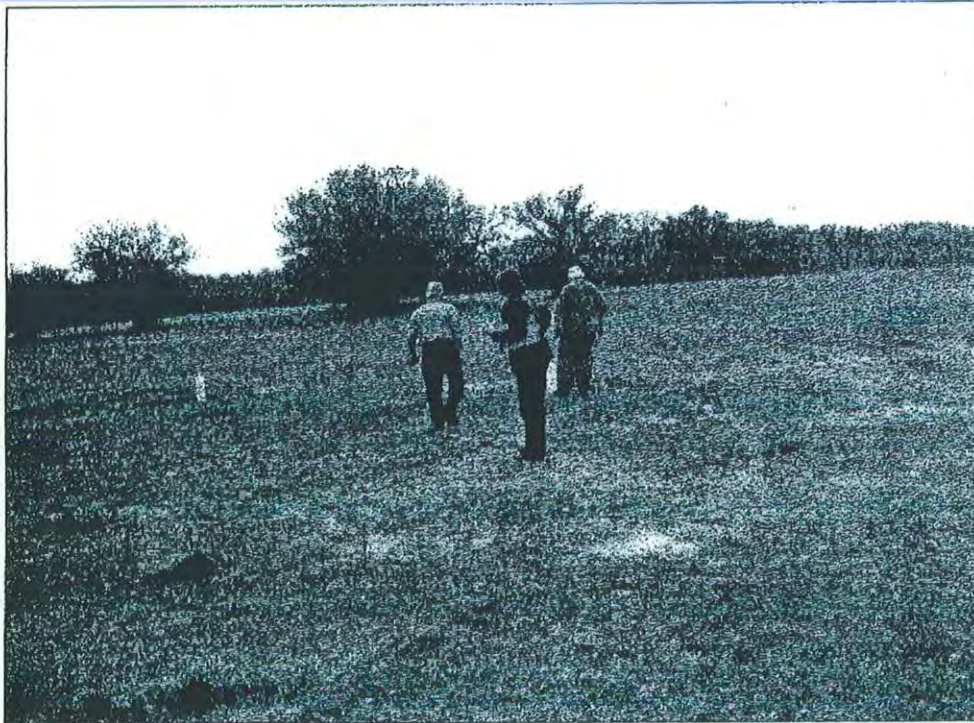
Goliad County Commissioner Jim Krenck, Mr. Art Dohmann, Ms. Margret Rutherford and Dr. H. C. Clark, representing the Goliad County group, were also present on March 7, 2007. At the groups' request, we met them at the property of Mr. Elder Ahrameit where they discussed the site conditions that prompted their complaint (see photograph 1).

Photo 1: Abrameit property with members of Goliad County group

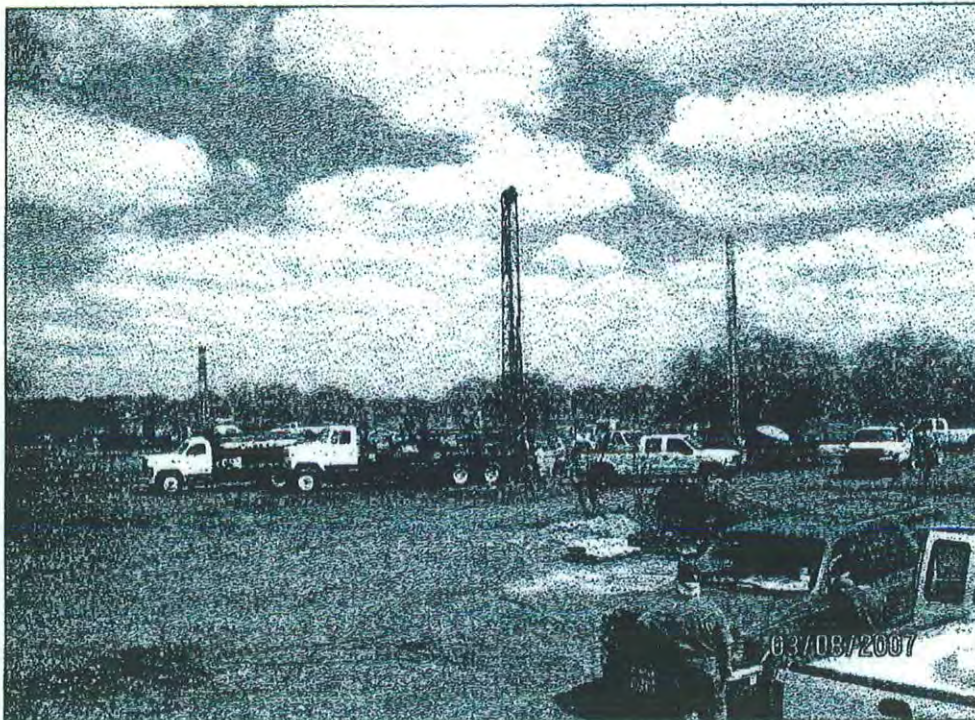
Photo 2: Three of the Four Drill Rigs Active During the Inspection

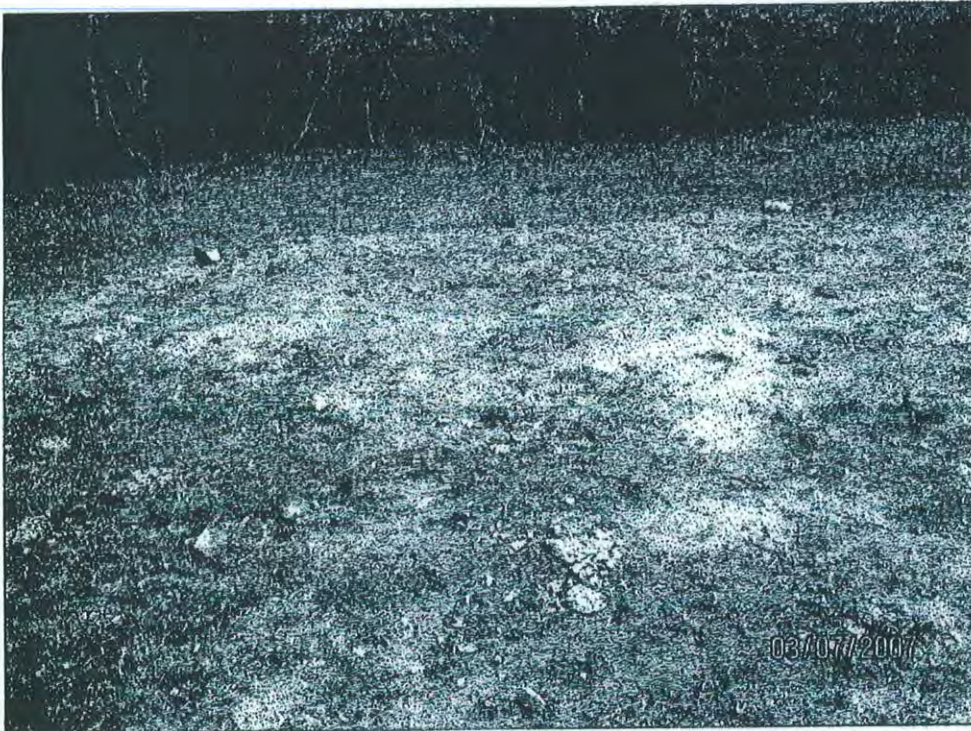
In Section IV A of the application, UEC states that, during drill site preparations, topsoil will be segregated from other soils and saved and later re-distributed. Topsoil was not re-distributed on the top of the majority of the drill sites inspected. In the 117 borehole sites inspected 74 were not fully re-topsoiled. Site 32892-84 (see photograph 3) exemplifies this drill site reclamation failure. Site 32892-84 is covered with a gray subsoil with little or no topsoil evident.

Photograph 3: Borehole 32892-84, Grey Subsoil on Surface

Based on observations made during this field inspection I believed that UEC was not in compliance with their Exploration Permit and the Regulations and issued Notice of Violation 080A. The Notice of Violation requires that UEC install a concrete surface plug at all sites, mark the exact location of each borehole for verification by the Commission, and remove all drilling mud, cuttings, cement and other debris burying it with no less than one foot of topsoil. UEC is directed to complete the remedial action by April 12, 2007.

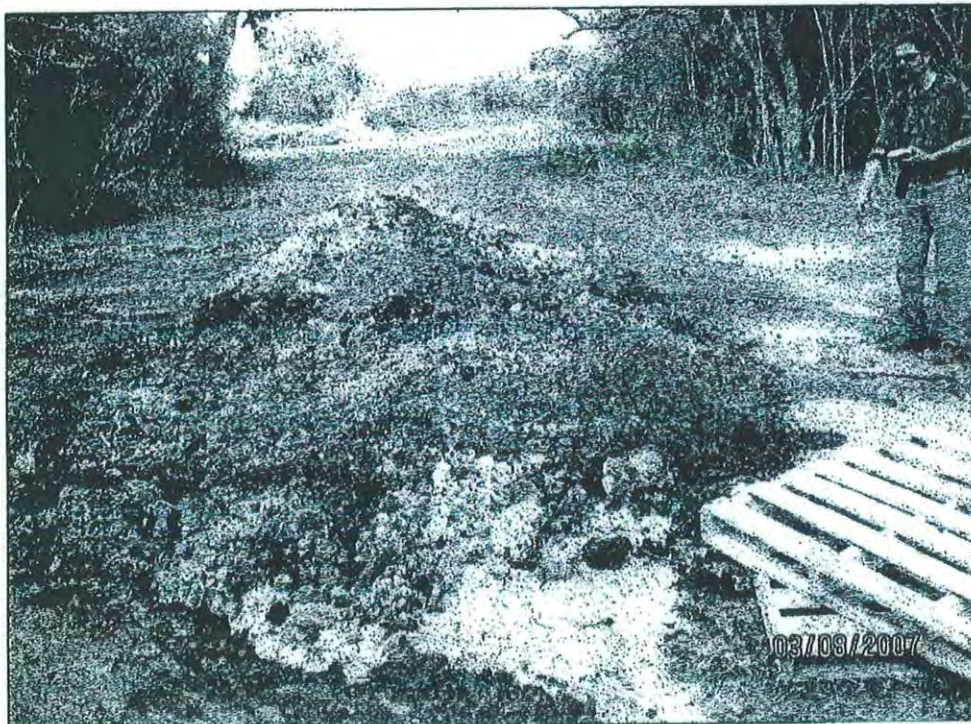
Photograph 4: Drilling fluids excursion from mud pit

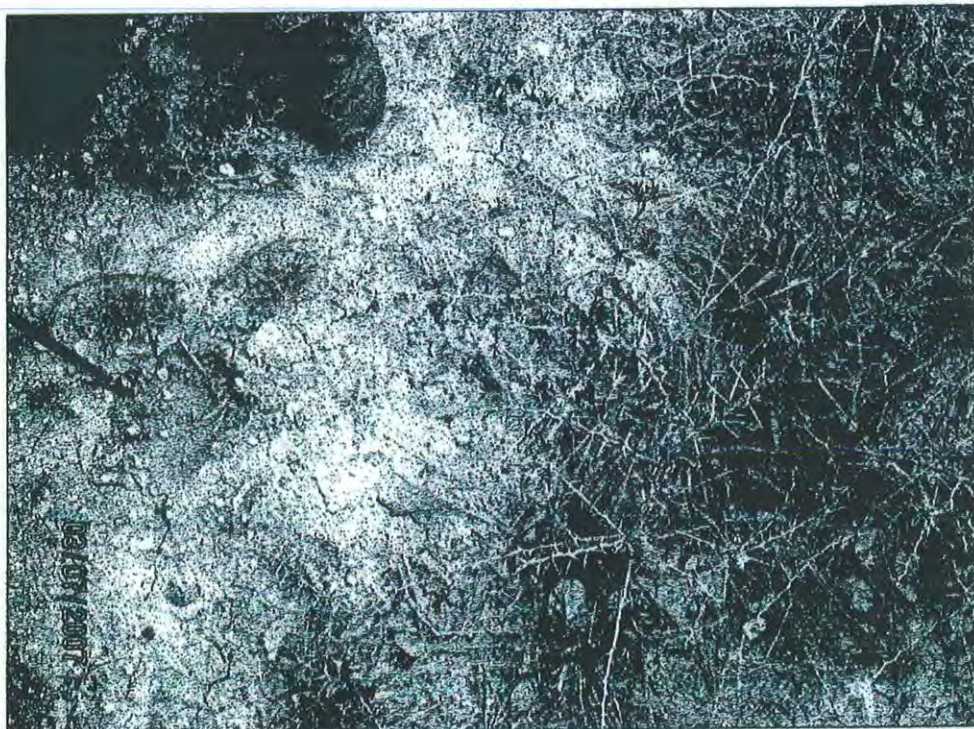
In Section IV A of the application, UEC states that mud pits will be allowed to dry before being backfilled with subsoil and cuttings. This drying aids in preventing excursions semi-solid drilling fluids. I observed at the active sites that drilling pits were being backfilled very quickly after the hole was logged with no drying period (see photograph 4). This process caused lighter drilling liquids to be crowded out of the pit and flow on to the surface. Evidence of this reclamation failure was also evident in the several older drill holes including Borehole 32892-84 where drilling fluids or cuttings were found on the surface (see photograph 5).

Photograph 5: Borehole 32892-84 cuttings from pit on surface

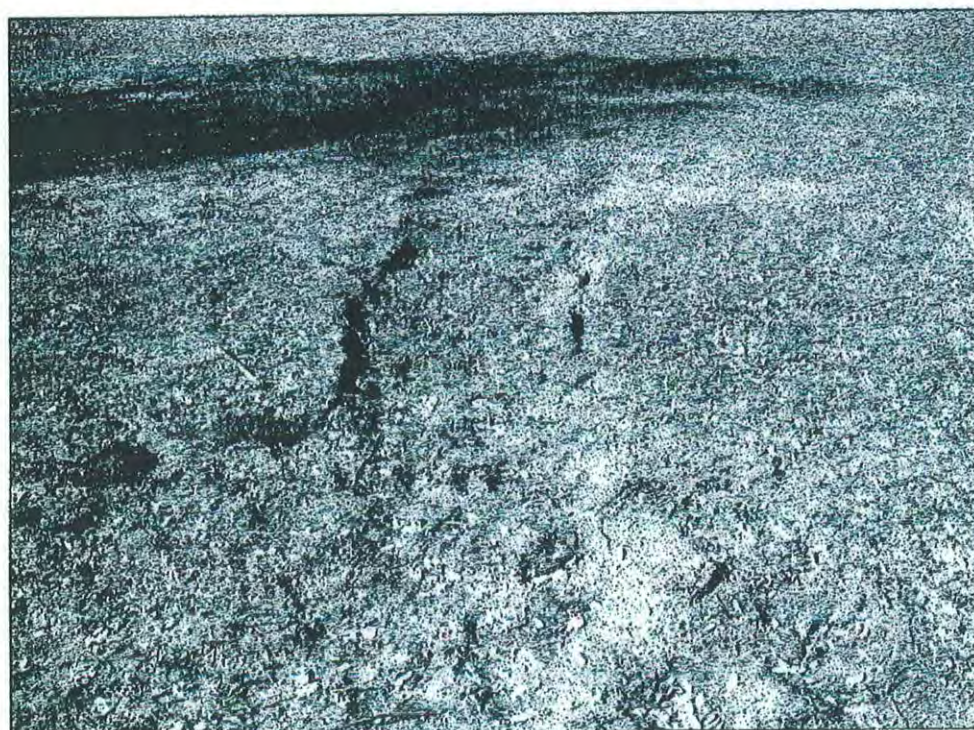
In Section IV A of the application, UEC states that mud pit areas will be backfilled to above grade to allow for settling. This precaution is designed to prevent the formation of depressions in the pasturelands drilled. Eleven of the 117 boreholes inspected had depression areas forming over the mud pits. Borehole 32201-N40 is an example of this backfilling failure (see photograph 6).

Photograph 6: Borehole 32201-N40 Mud Pit Depression

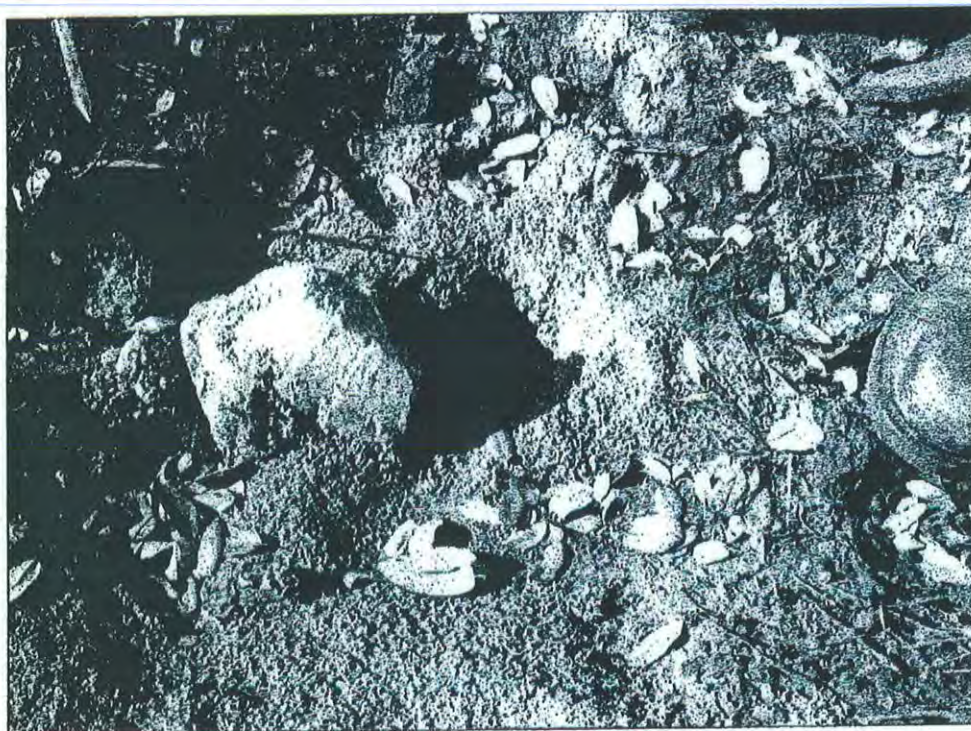
As required by the Commission's permit issuance letter, each borehole drilled in this project is required to have a ten-foot surface plug located three feet below the surface. The majority of the borehole locations were unable to be located for verification. Of the fourteen boreholes located, five were found to be open to the surface with the cement plug estimated to be greater than 20 feet below the surface and the remainder of the plugs found were between 0 and 18 inches below the surface. Borehole 32201-N38 (see photograph 7) is an example of this plugging failure.

Photograph 7: Borehole 32201-N38 No Surface Plug

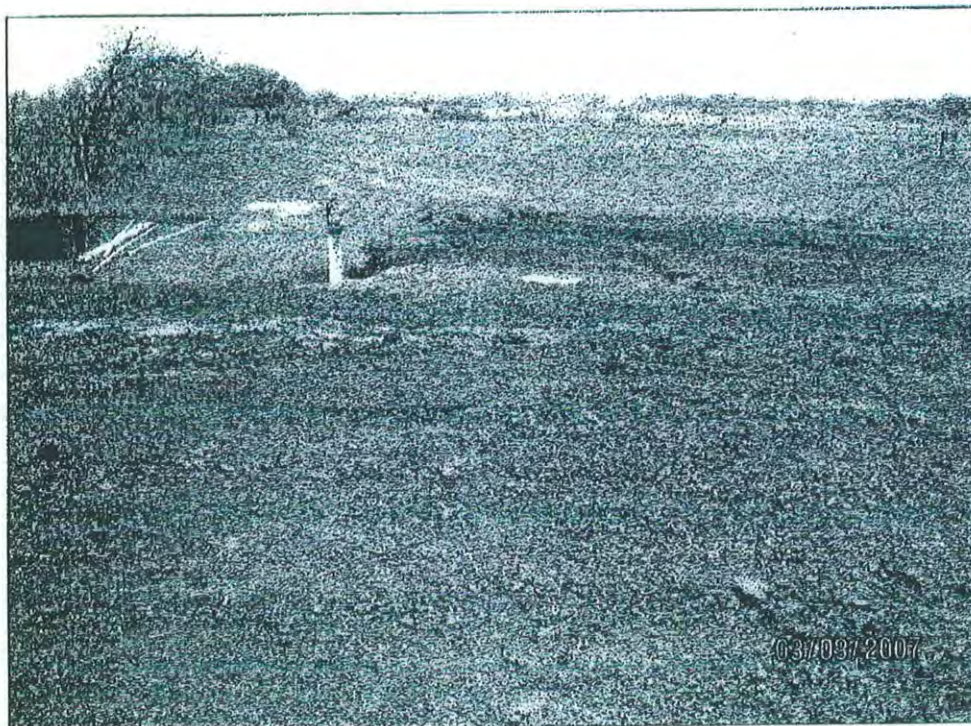
Several sites were inspected where the surface reclamation had been done in accordance with the performance standards contained in UEC's Permit No. 123 (see photographs 8 and 9).

Photograph 8: Jacobs Water Well Reclamation Site

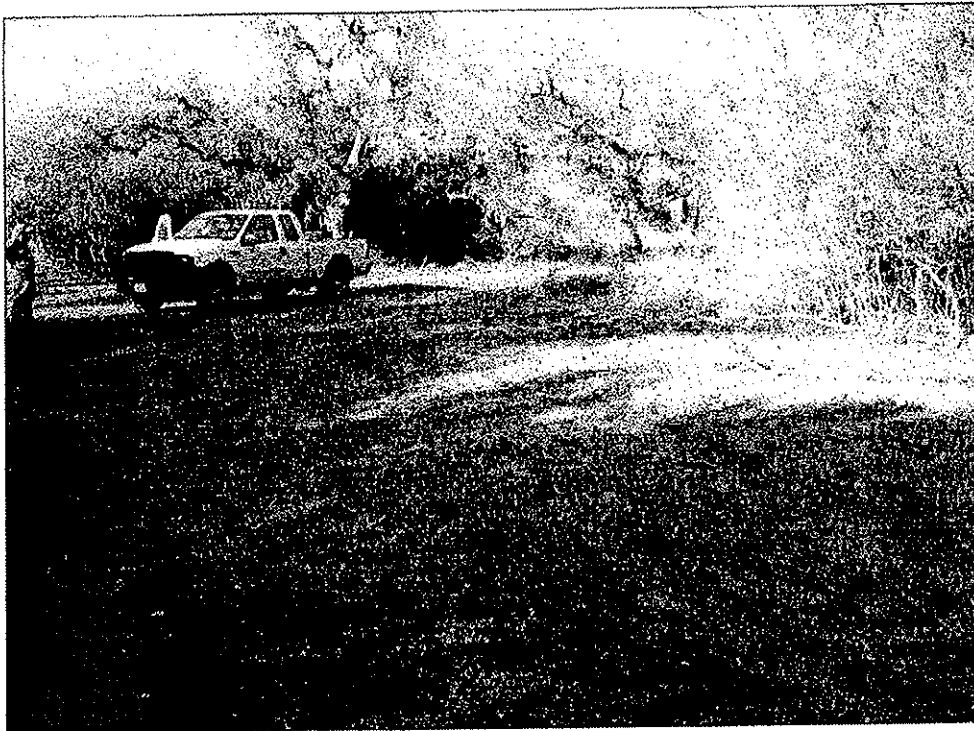
Photograph 9: Location 32208-32 Reclamation Site
